Some Causes of Erosion and Sediment Deposition in the Lower Reaches of Cubberla Creek and Photopoint Monitoring of Change

By Ray E. Kelly

Source: Robin Trotter (ed.), *Cubberla and Witton Creeks, Their physical characteristics and land use over time, Proceedings of Symposia held in 2000 and 2001 on the Cubberla and Witton Creek Catchments*, 2001 Brisbane, Cubberla-Witton Catchments Network.

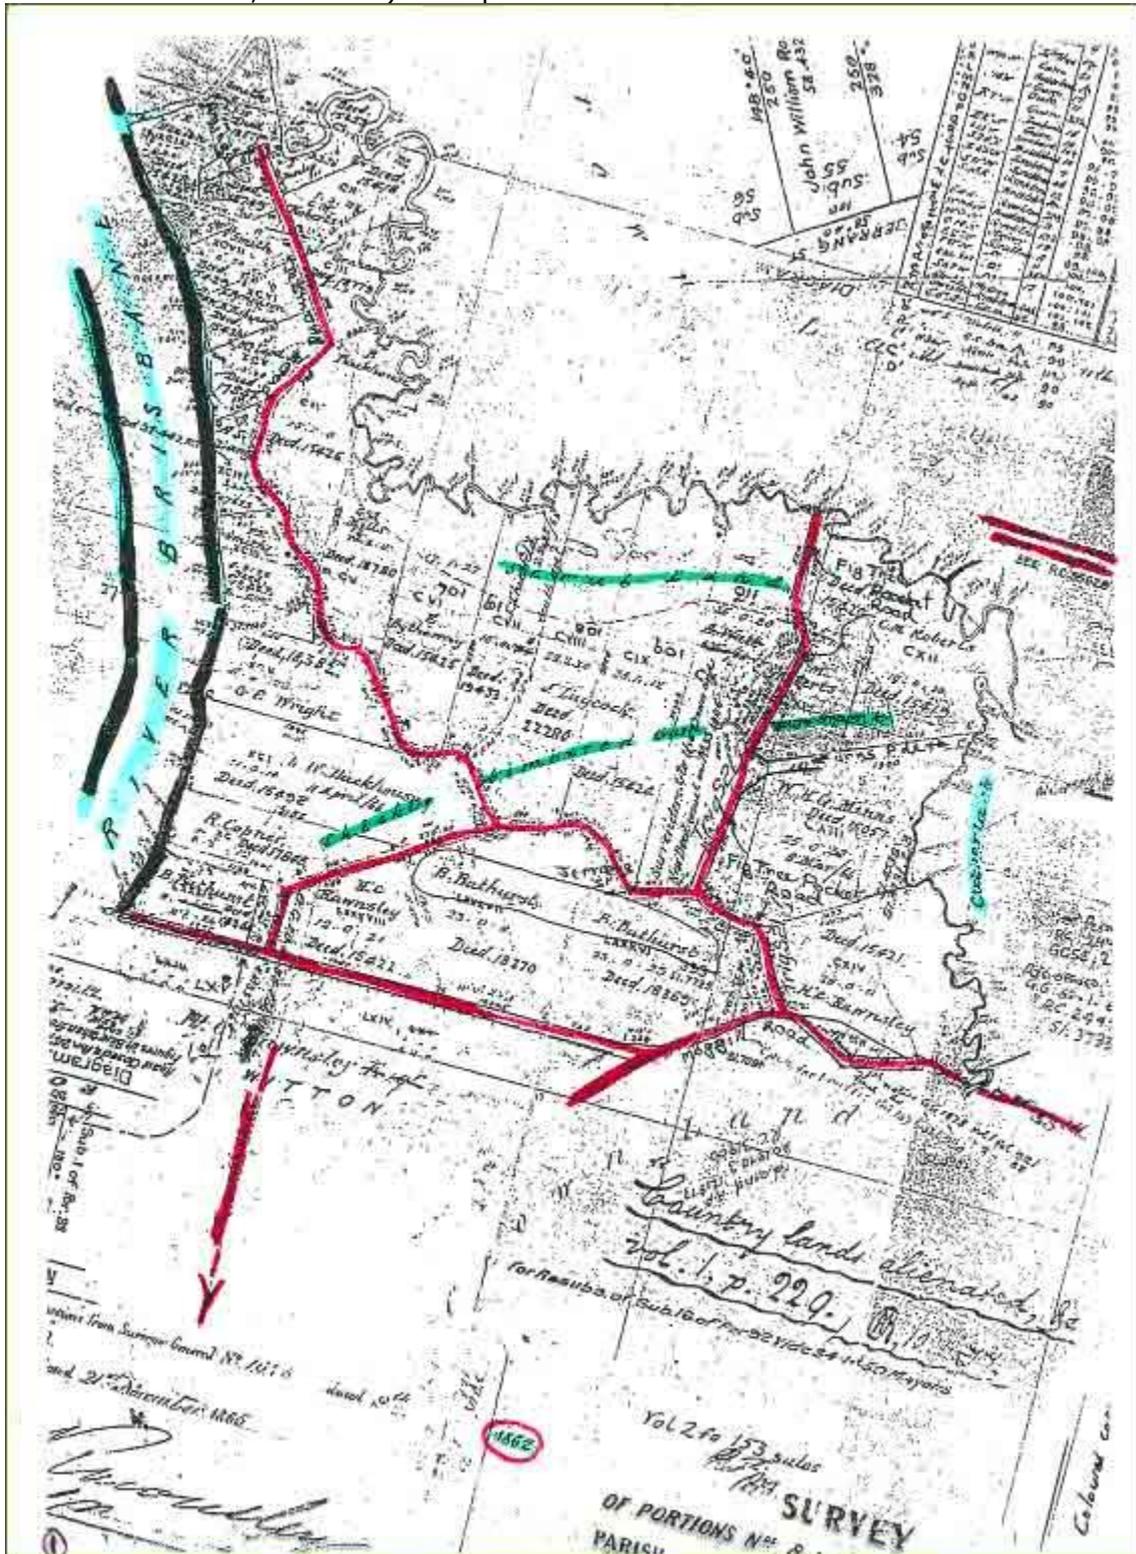
Fig. 1 Survey map showing portion of Cubberla Creek 1862 (Source: Department of Natural Resources, Brisbane). This plan was drawn with North to the bottom.

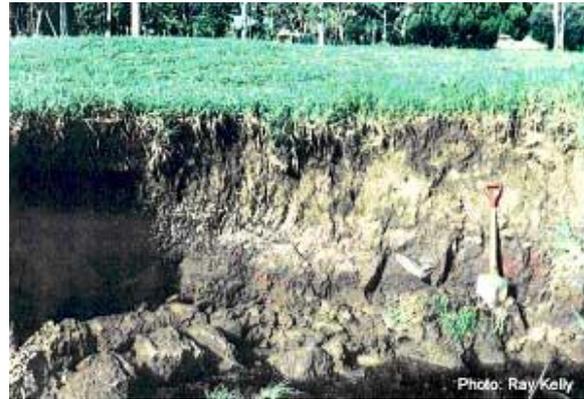
gradient is that water flow is faster and its extra energy has the ability to cause accelerated erosion of the creek bed and banks (**Fig. 4**). Through recent years this erosion has been very apparent along the creek. Erosion usually takes the form of deepening of the bed or undermining of the banks with the mobilised sediment being transported by the water. When the sediment load increases water velocity will decrease to a point where sediment is released and velocity then increases to a speed at which it will cause erosion again. This explanation may be over simplified but the erosion / deposition, or deepening / aggrading process has been observed through the last few decades. The present situation is that for most of its length through Cliveden Park the bed and banks are relatively well vegetated and erosion is not greatly active. This stability could be changed by flood events during the coming wet season.

During the Bicentennial Year, 1988, a study was made of the Land of Fig Tree Pocket (Kelly 1988) in which a photograph was shown of a foot-bridge over Cubberla Creek at Cliveden Park (**Fig. 4**). This bridge was undermined in a flood and a replacement was built about 15 metres downstream. The northern abutment concrete block was left *in situ* when the new bridge was built. A photo taken in December 1994 shows the remains of the north side abutment or foundation of the old bridge (**Fig. 6**).

Fig. 4 Eroded creek banks - Cliveden Park. Photograph taken 1988

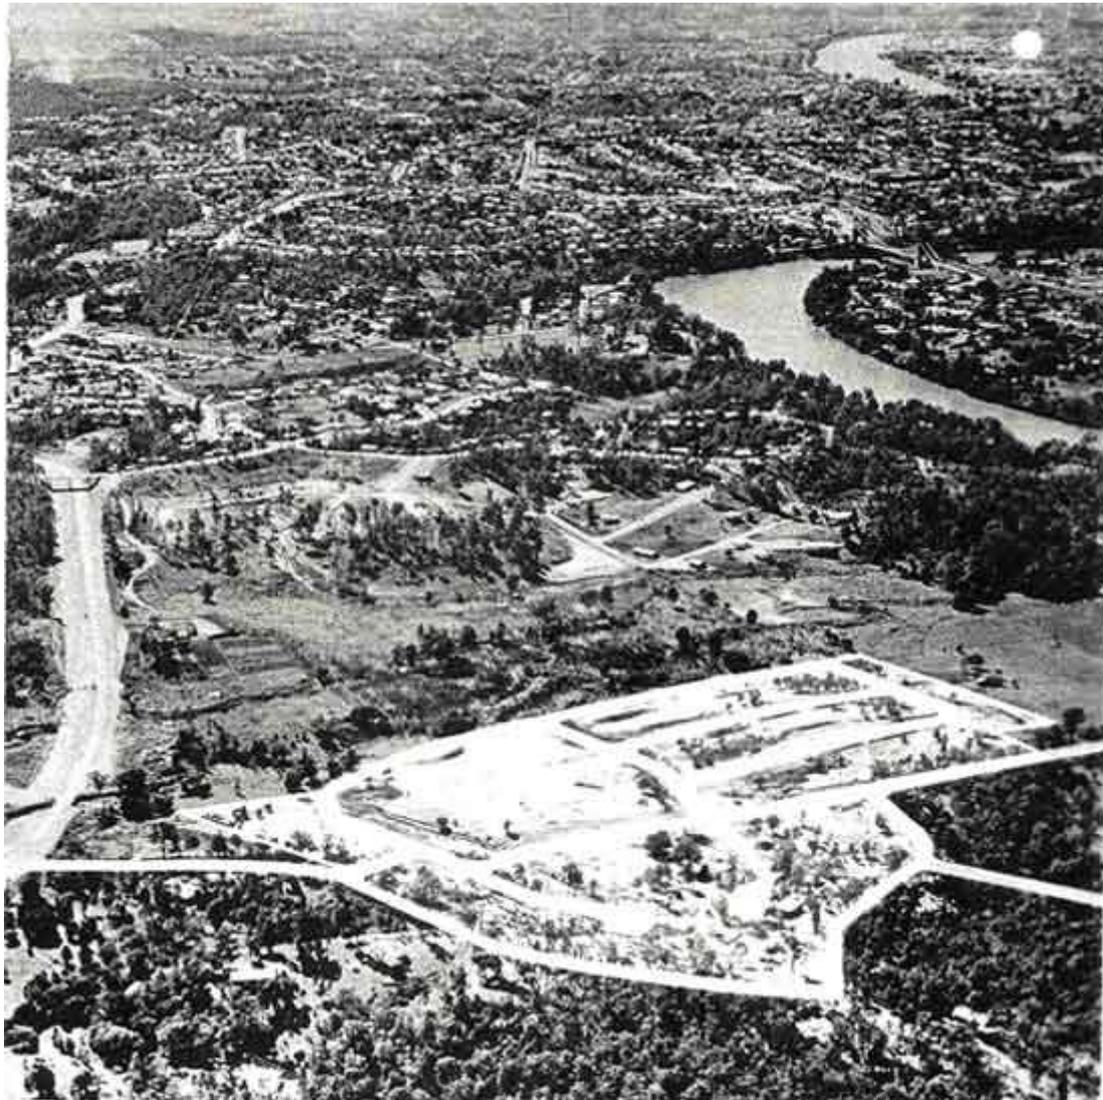
Fig. 3 Aerial view of Cliveden Park. (Source: *Cliveden Estate Development Plan*)

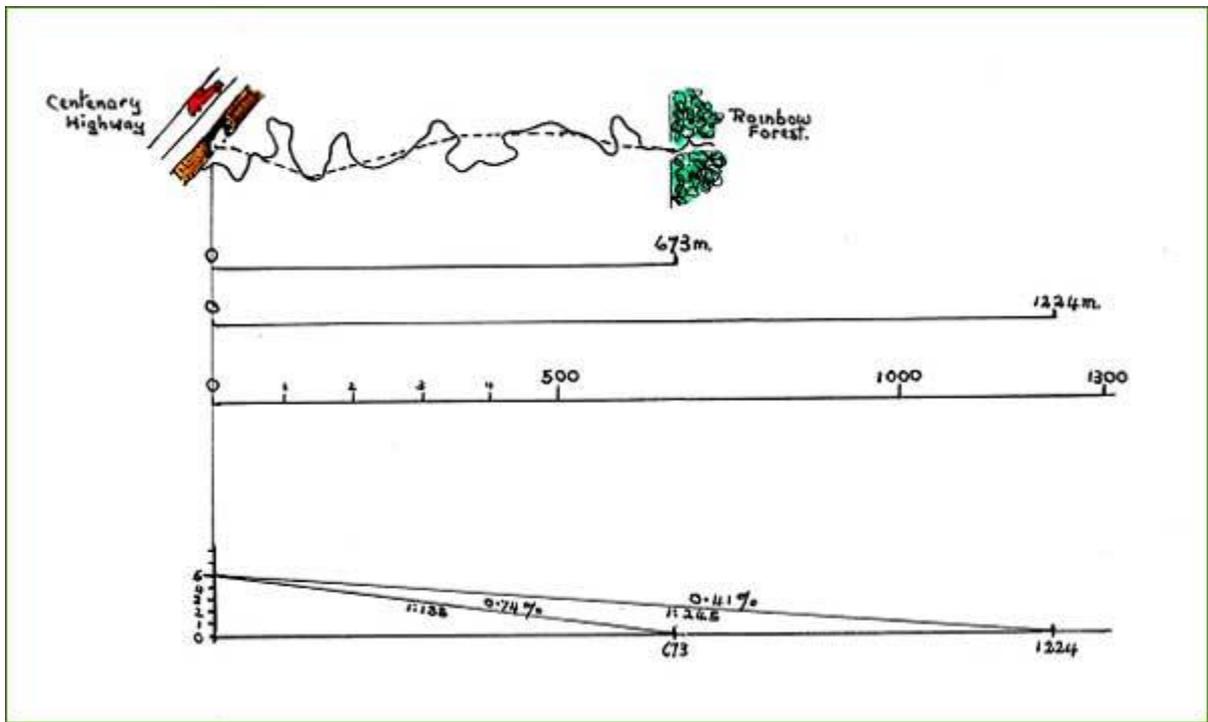
A survey of the line of the creek in 2000 shows that the length of the new channel through Cliveden Park is now 673 metres. The present length is 45% of that 140 years ago. By reducing the length whilst retaining the hydraulic head the overall gradient of the stream has been increased from 1:245 (or 0.41%) to 1: 135 (or 0.74%). A result of the steeper

Rainbow Forest is relatively well vegetated, and has a stream gradient of 1:500 (or 0.2%) (**Fig. 5**). High stream flows that pick up and carry both sediment and rubbish through Cliveden Park rapidly slow down in Rainbow Forest and the load is deposited just inside the Forest. Large vegetation weirs build up from flood flows and plastic and other consumer rubbish is deposited. Sand and gravel deposition beds that were visible at the upper section of the Forest are now to be seen at least 600 metres downstream. The ecology of forest stream environment is thus being changed from a clay bed to a sandy / gravelly bed, and may result in a change in the local aquatic communities.

Fig 5. Diagram showing changes in gradients associated with straightening of the creek.

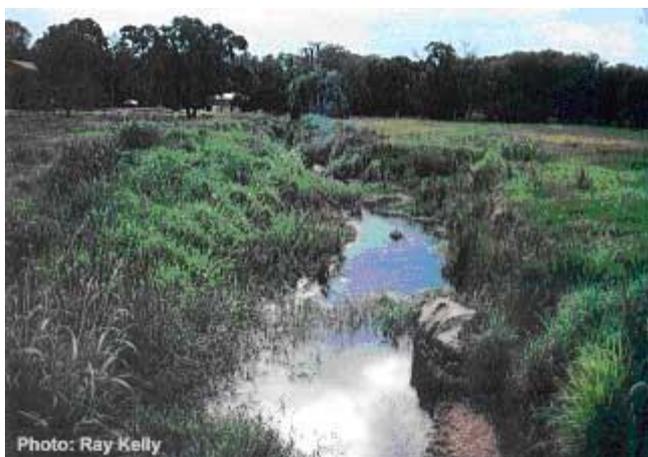
Fig. 6 Remains of foundations of first bridge

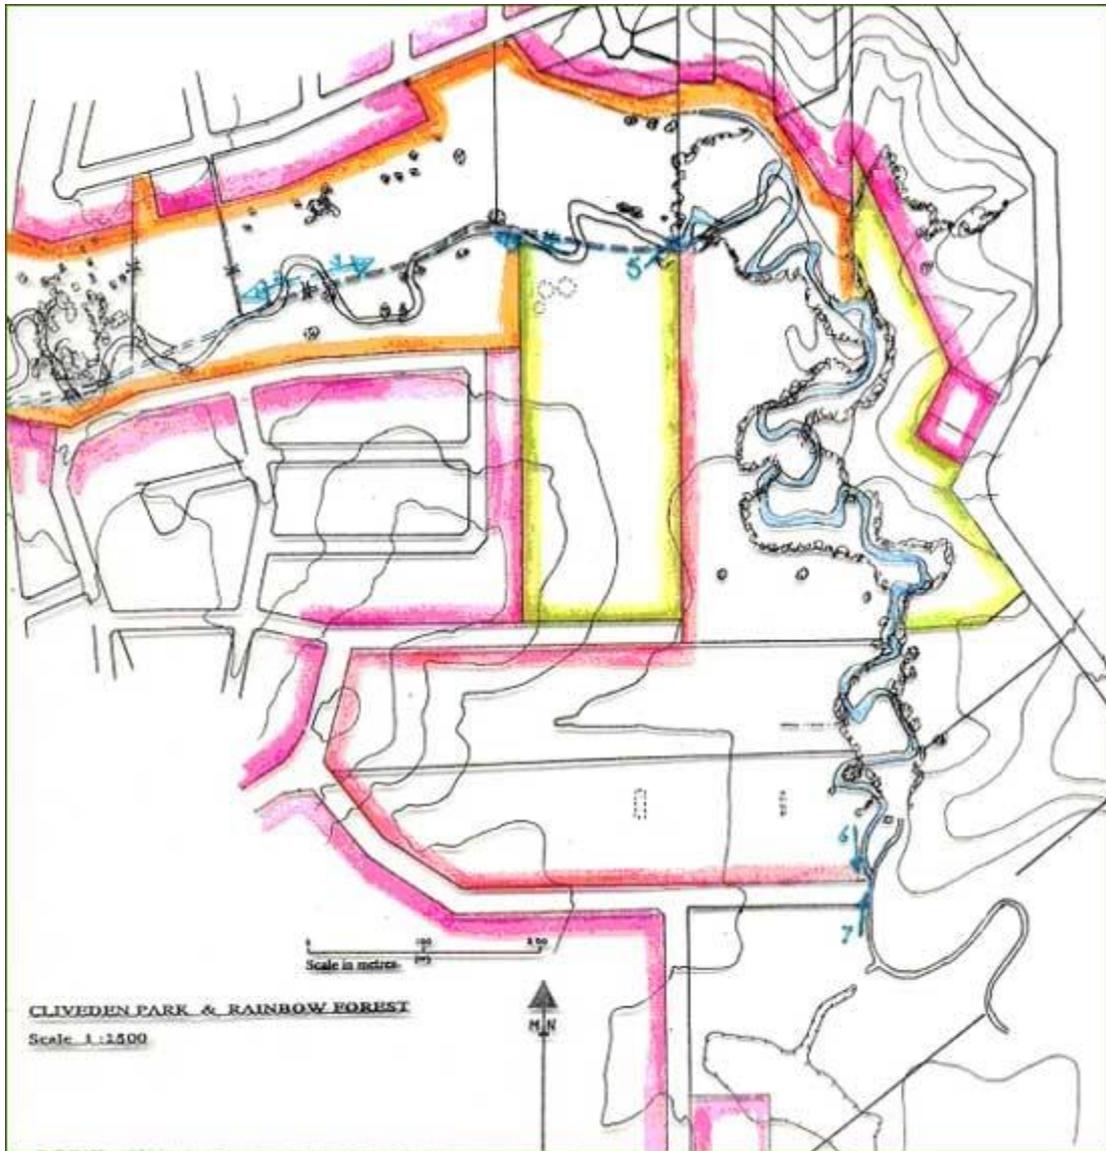
Fig. 7 Photopoint monitoring points

Note: Photopoint number and direction are indicated with No (1), and an arrow indicating the direction of photograph

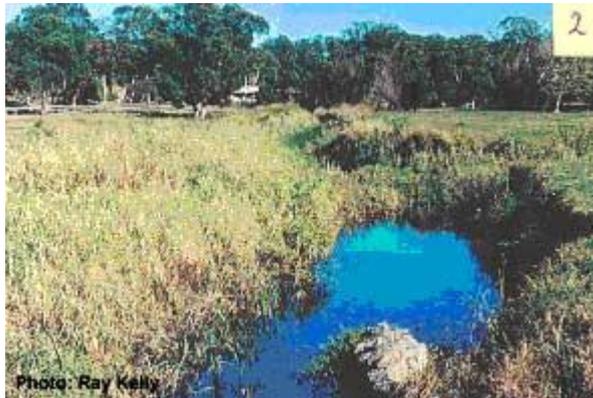
Fig. 8 July 1995 - Minor erosion of the north bank. Concrete block of the old bridge

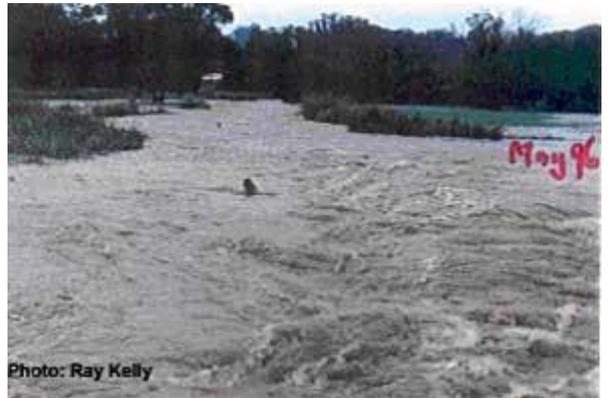
Fig. 9 May 1996 High flood - similar to flood in late January 1996

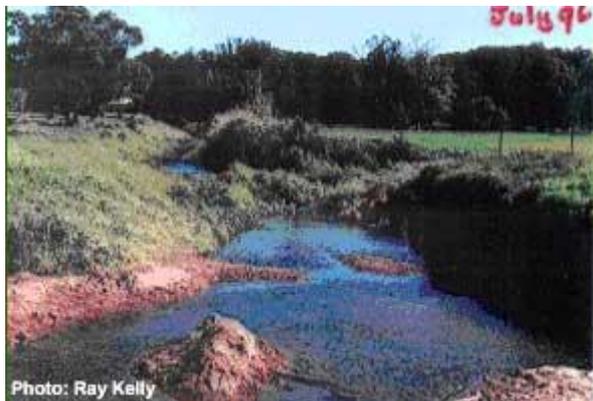
Fig. 10 July 1996 - severe bank erosion. Photopoint changed slightly to reposition the concrete block

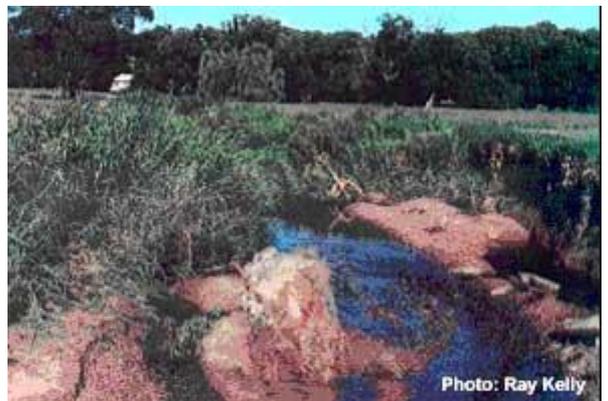
Fig. 11 March 1997 bed of creek deepened by 700mm and bank being undercut

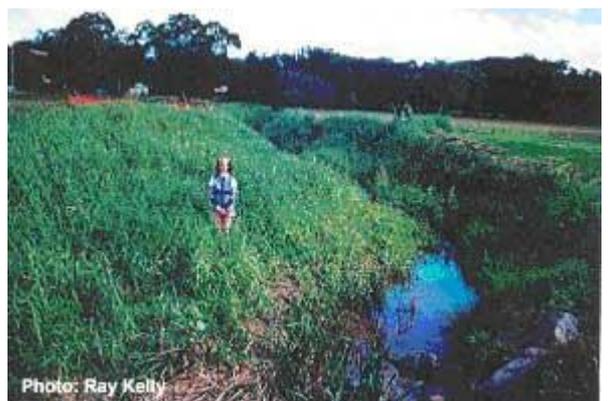
Fig. 13 July 1998. with the establishment of *Phragmites australis* the creek bed is vegetating

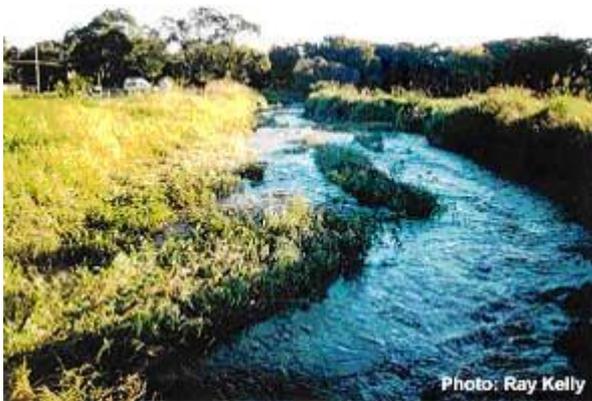
Fig. 14 July 1999. Some high creek flows were experienced.

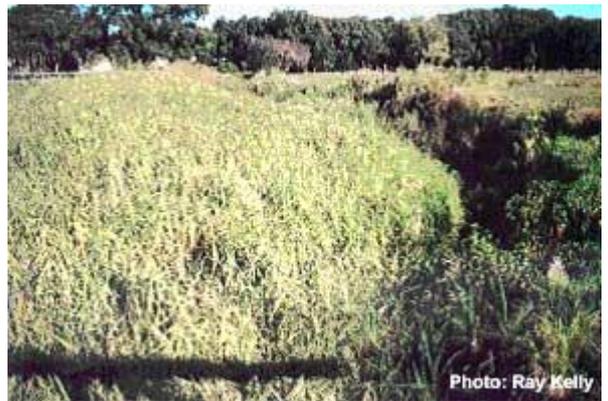
Fig. 15 July 2000. A well established revegetated creek bed against the rock lined north bank

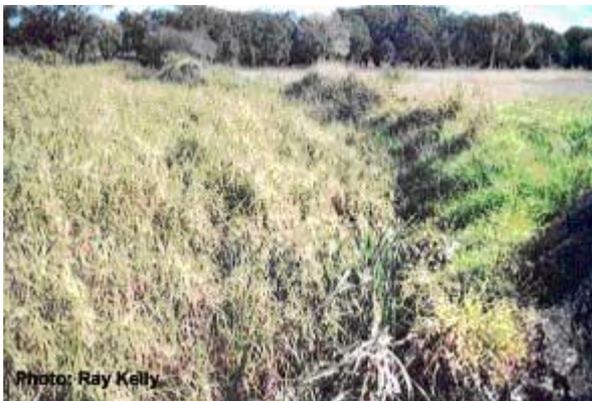
Fig. 16 July 2001. Kikuya grass on north bank and established *Phragmites* provides protection.
